# **Vermont Multifamily Onsite Report**

## ***FINAL REPORT***

**Vermont Department of Public Service**

**NMR Group, Inc.**

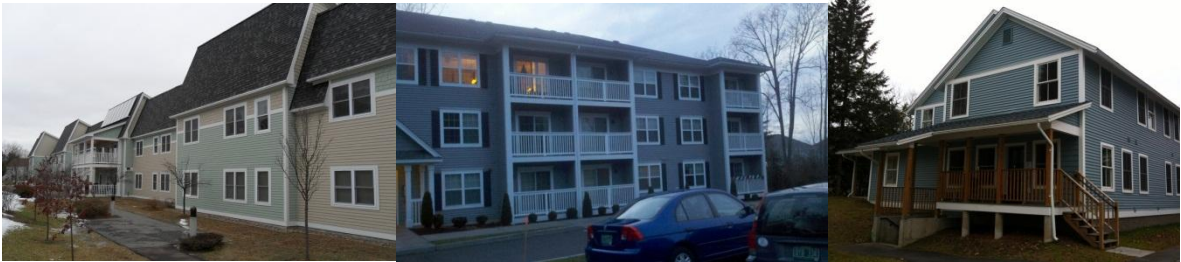
**Figure 2-1: Examples of Three Newly Constructed Multifamily Buildings**

Figure 2-1 and Figure 2-2 show examples of the newly constructed and existing multifamily buildings visited for this study.
